CHURCHMAN
FENNER & BROWN LTD

Case Study

Brunel Way

Concrete Repair & Graffiti Removal

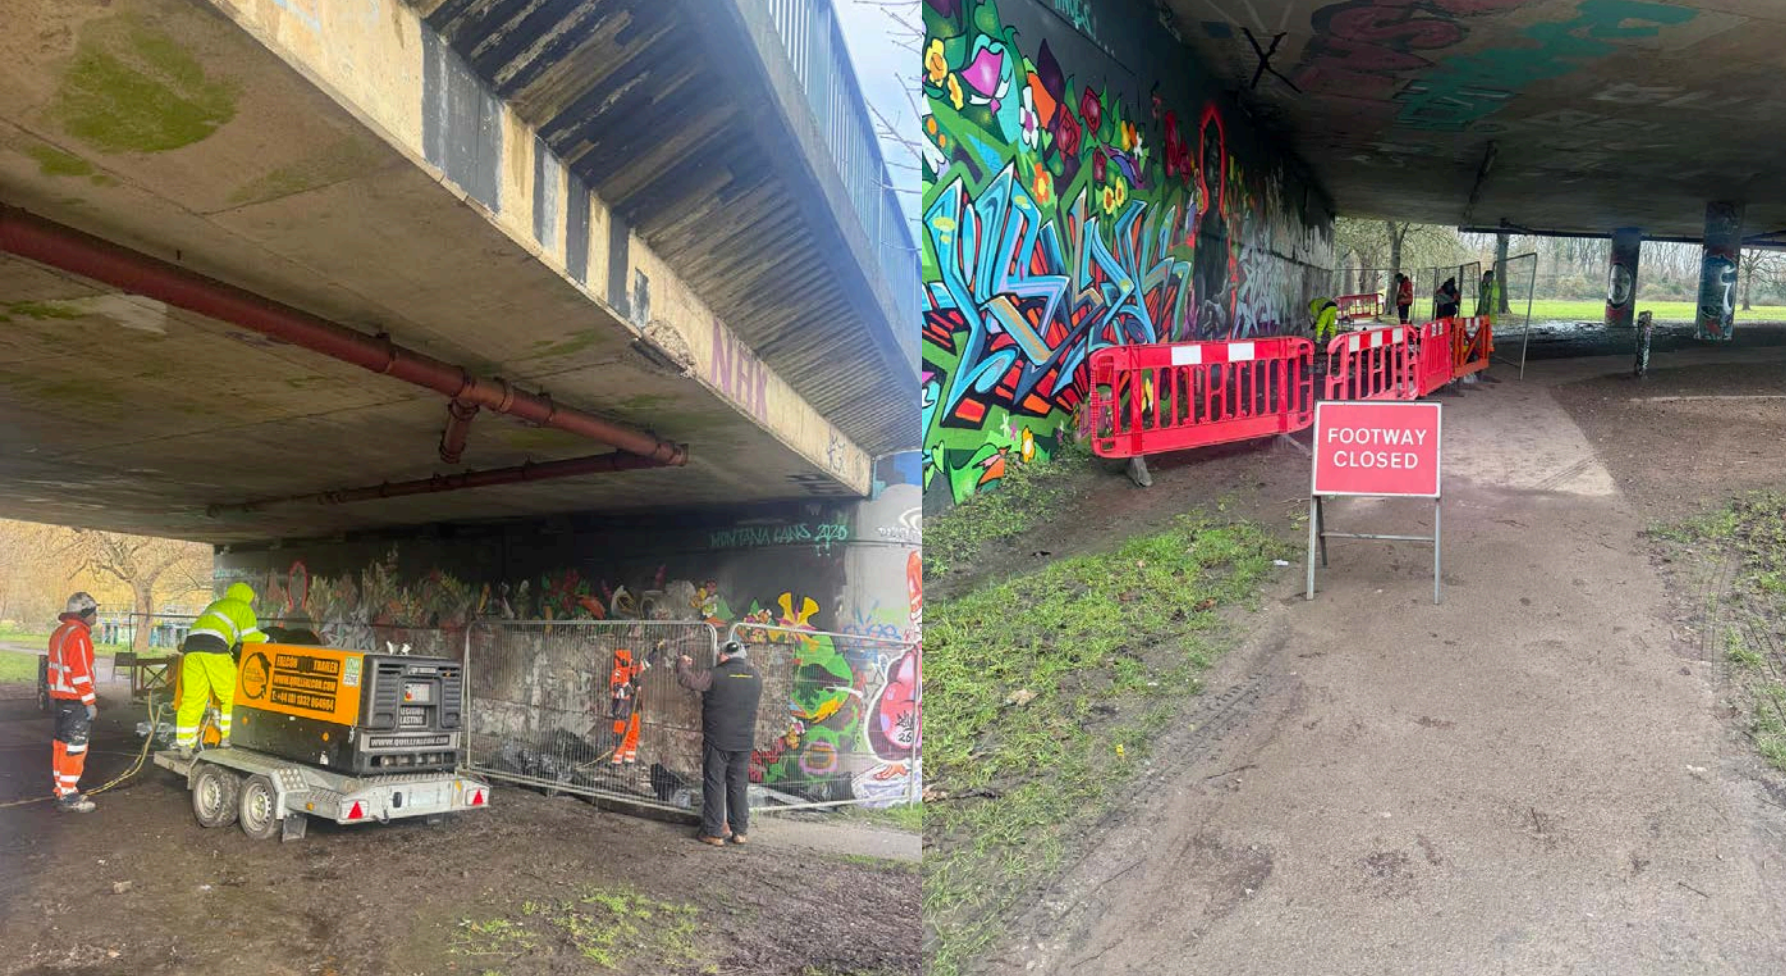
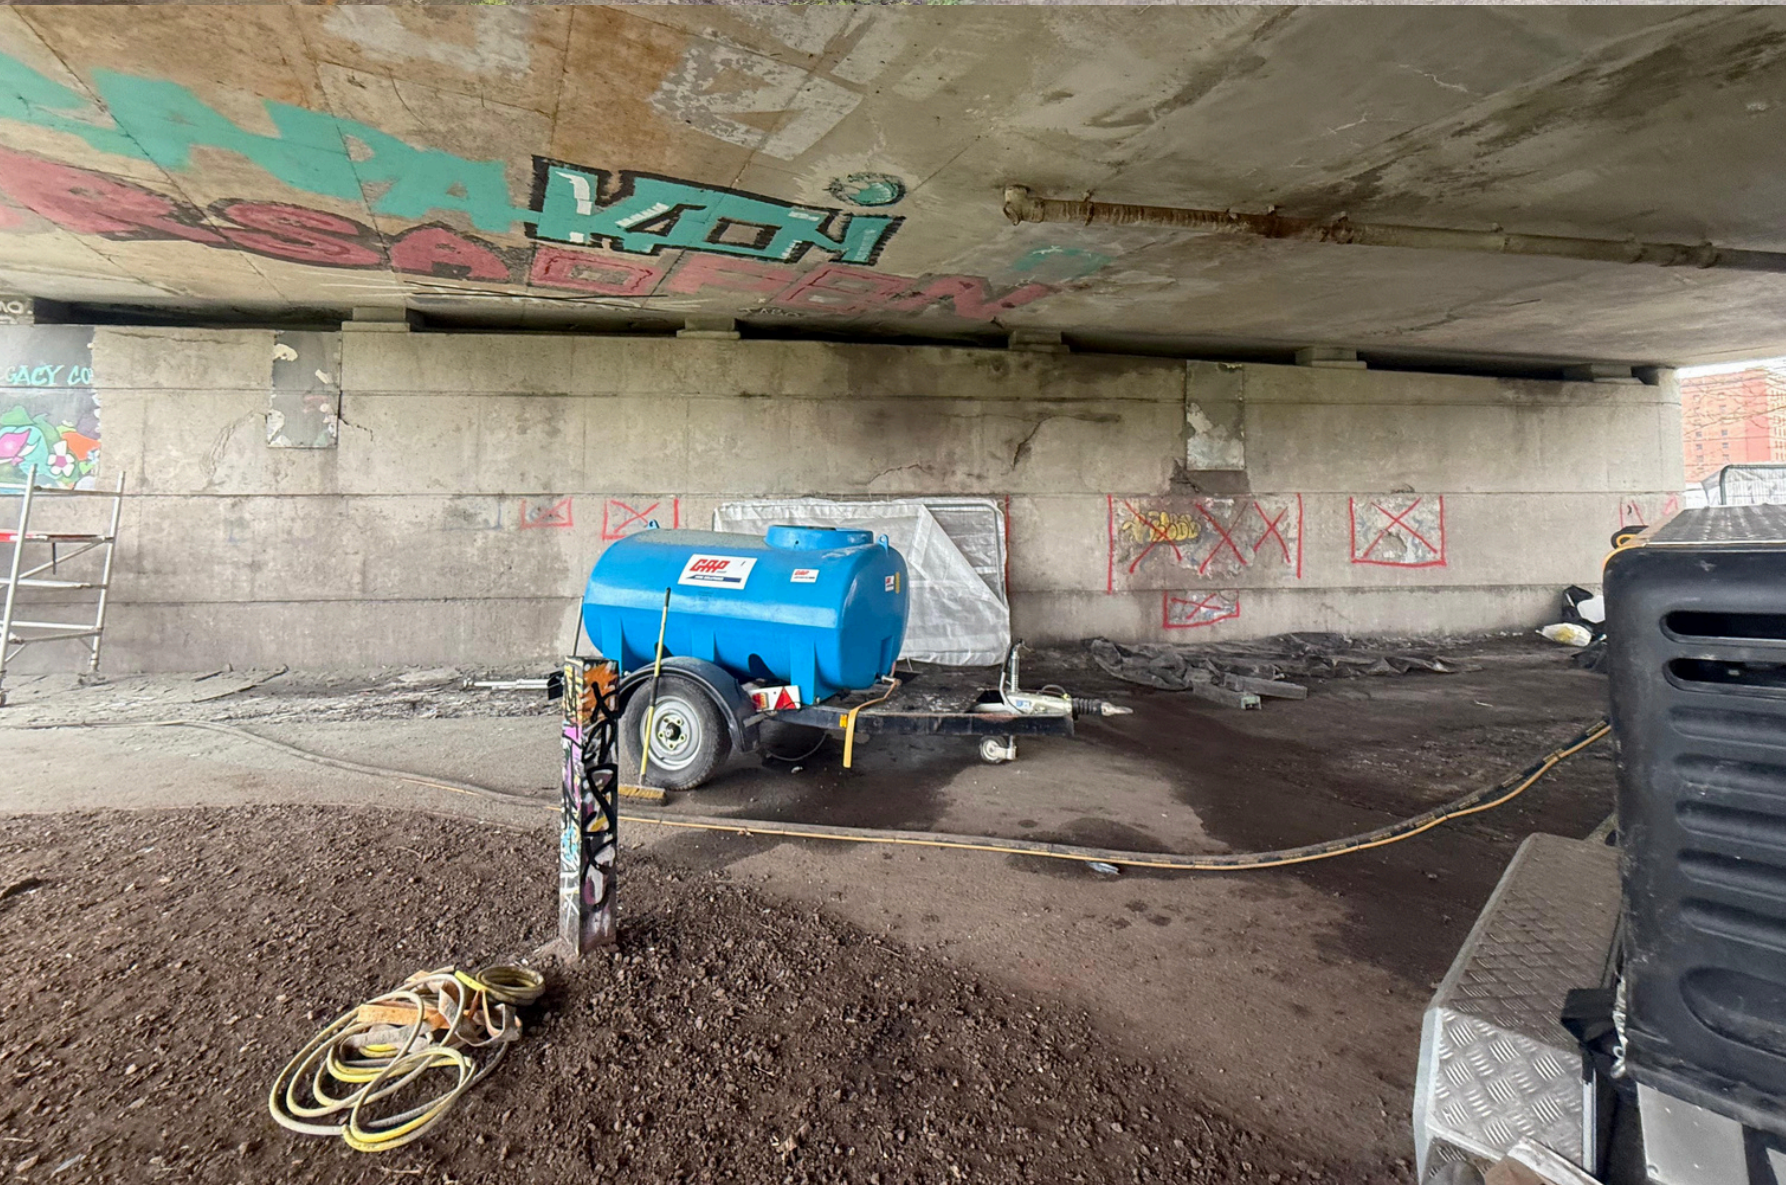
Graffiti Removal

Over 20 layers of Graffiti on the wall, CFB had to get the wall back to concrete so it could be surveyed to find out the condition of the underlying concrete.

To begin with we used small handheld breakers to remove the bulk of the graffiti. Following that, with thanks to Quill Falcon on-site training the CFB team were trained to use the Quill Falcon Dustless blasting system. All remaining graffiti was then blasted & concrete exposed.
