# Case Study

## 11-14 GEORGE STREET, SOMERCOTES

### PROJECT SPECIFICATION

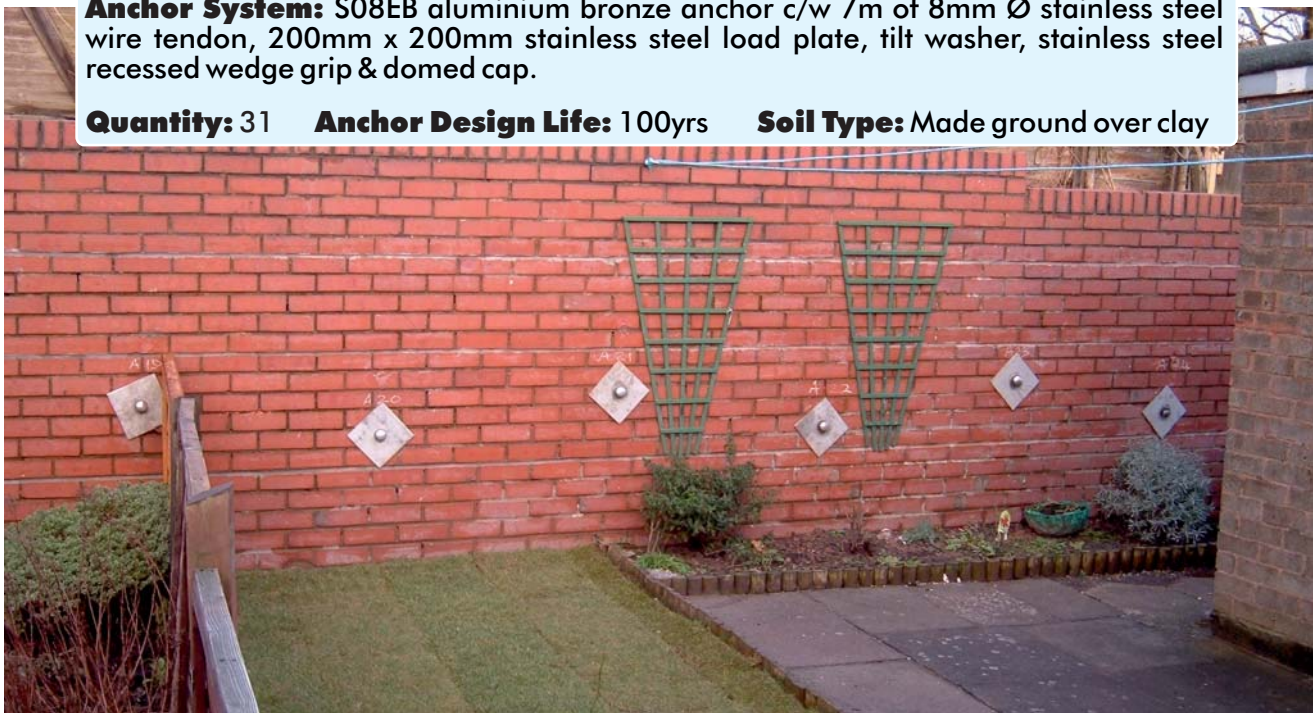
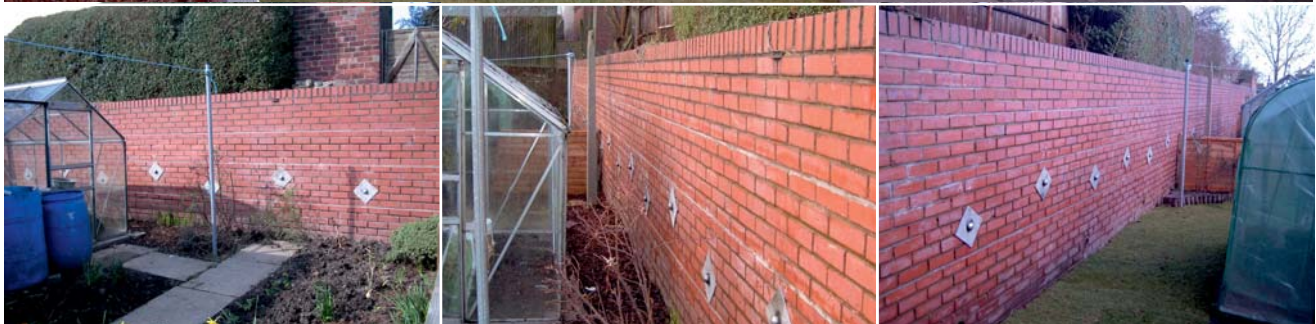
This 2m high boundary wall extends some 50m behind four bungalows. Retaining to its full height the wall was exhibiting signs of stress cracking and had rotated enough out of vertical to cause concern to the local elderly residents. Remedial work was required to repair the cracks and anchors were needed to stabilise the wall from further rotational movement and potential collapse.

The main contractor carried out all site works including the joint repair and installation of internal reinforcement bars into the wall. Stress cracks were identified and stitched. 95mm Ø core holes were cut through the wall on calculated centres and anchors were installed, 15° below the horizontal, to a depth of 5.5m. Each anchor was then proof tested and locked off against the wall face using a load plate, recessed wedge grip and smooth domed cap. Anchor installation was designed and indemnified through Platipus®. Working within the restrictions of the garden area all works had to be completed using lightweight hand held equipment.

**Anchor System:** S08EB aluminium bronze anchor c/w 7m of 8mm Ø stainless steel wire tendon, 200mm x 200mm stainless steel load plate, tilt washer, stainless steel recessed wedge grip & domed cap.
